# Recent events, operating experience related to fire protection

2<sup>nd</sup> Topical Peer Review – 1<sup>st</sup> Stakeholder Engagement event

*Virtual meeting, 22 June 2021*

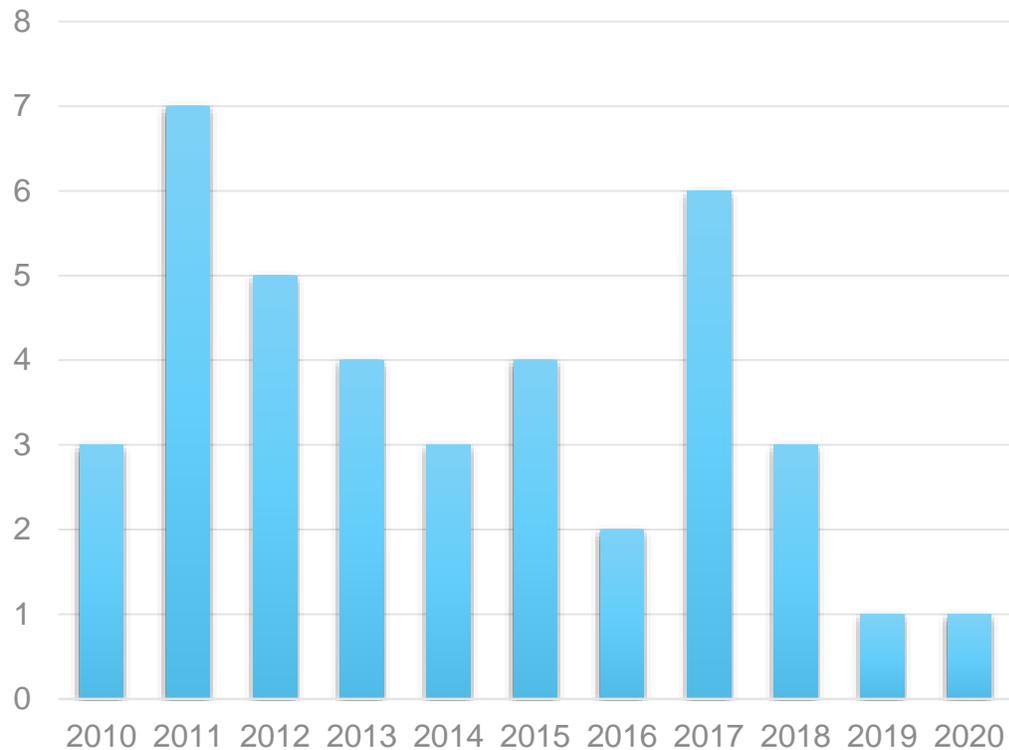
Number of events

39 events related to fire reported in the last years, (~ 5% from total)

Most of them are rated INES 0 or 1
